MEADOW RUN DAM

NDI ID NO. PA-00555

PHASE I INSPECTION REPORT  
NATIONAL DAM INSPECTION PROGRAM

JUNE 1980

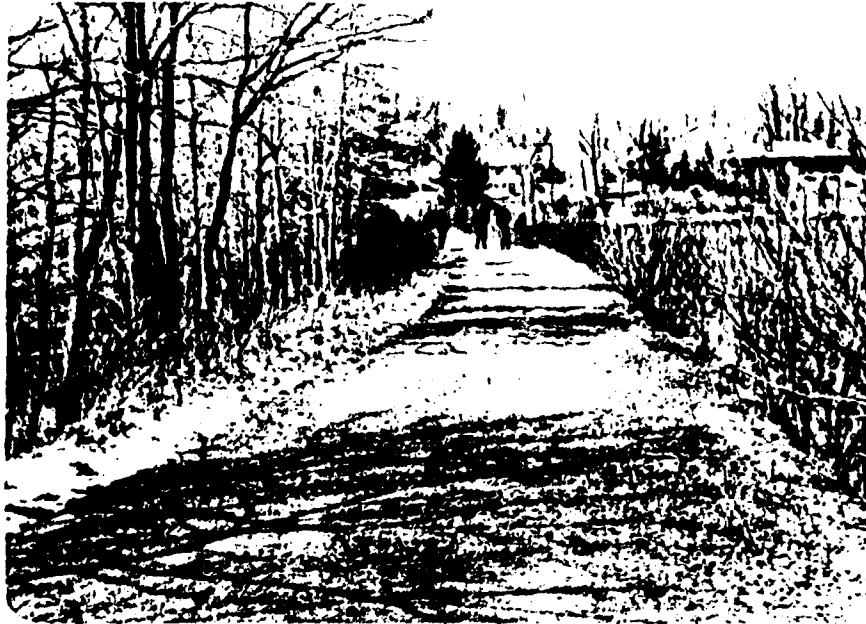
b. Embankment. The upstream slope of the embankment is covered by sparsely-growing, high brush (Photograph A, B and C). There are some eroded areas on the upstream slope. They are typically 10 to 15 feet long (Photograph C). Parts of the upstream slope above normal pool elevation are near-vertical. The top of the dam is curved in plan, with the part to the left of the outlet works deflecting downstream. Near the point of deflection, which is the highest section of the embankment, there are narrow cracks on the top of the dam that are parallel to the axis of the dam. One 8-foot long crack near the upstream edge of the top and two 3-foot long cracks near the downstream edge were observed. The cracks are hairline in width and their depth could not be probed.

A. Top of Dam

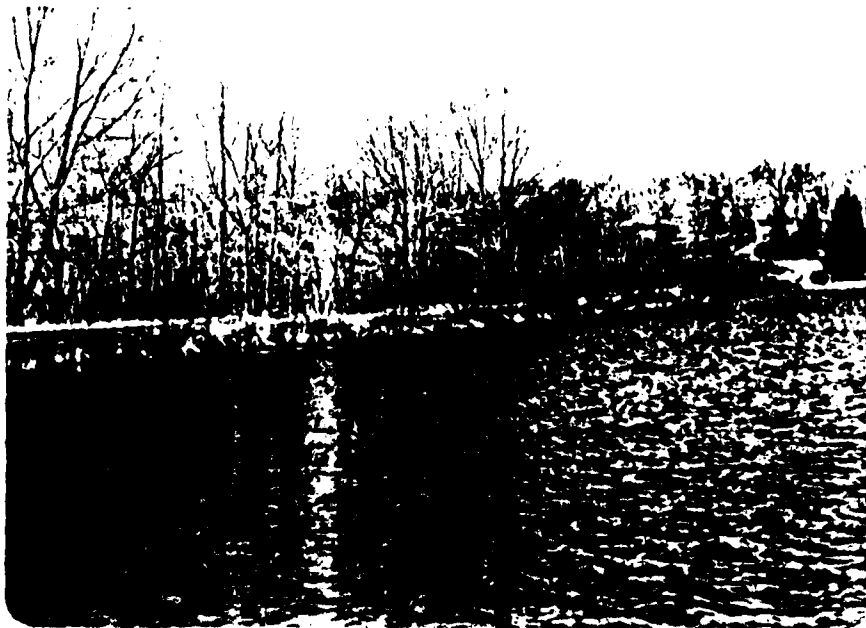
B. Upstream Slope

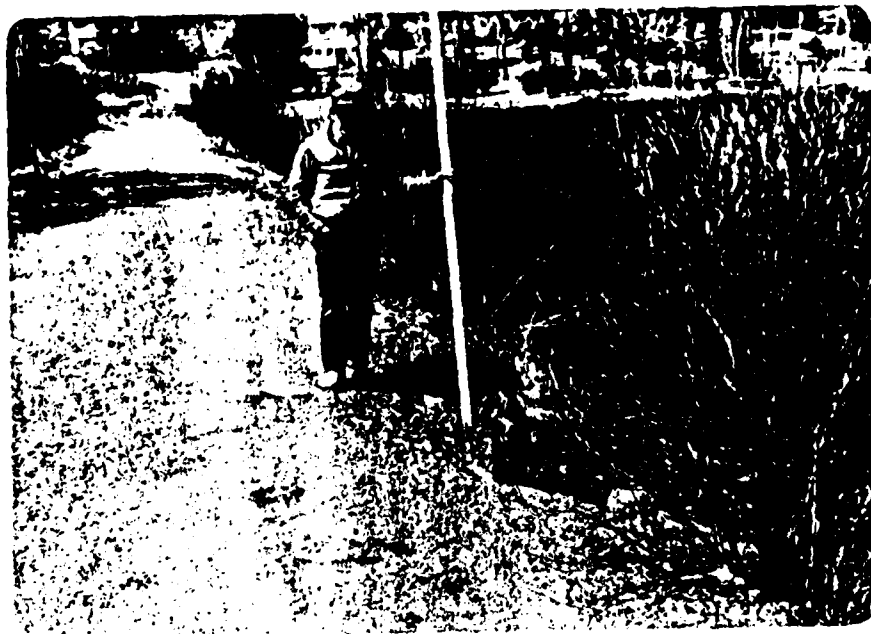
C. Upstream Slope

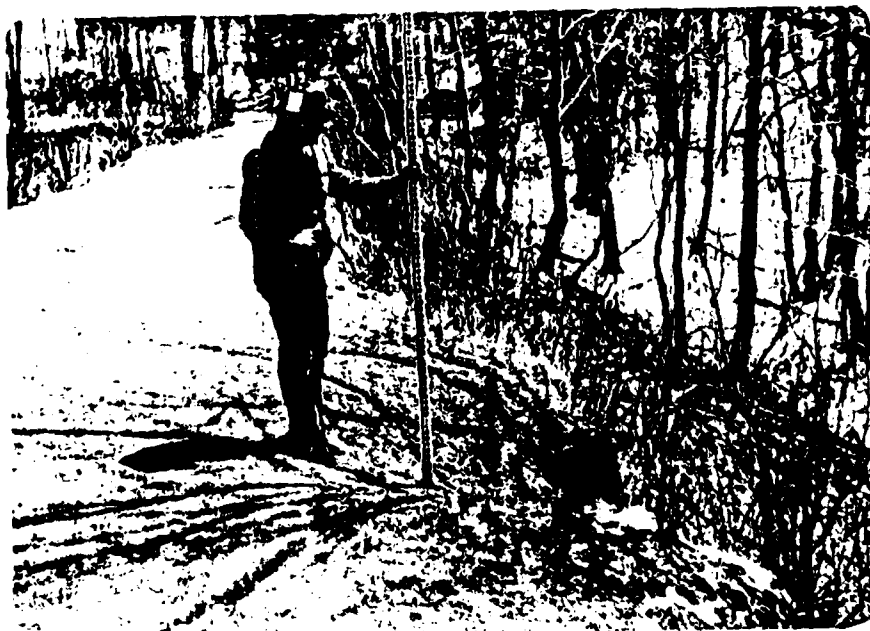
There is a minor surface runoff swale eroded into the downstream edge of the top near the outlet works (Photograph D). The downstream slope is covered with mature trees and brush growing through the stone cover (Photograph E). The downstream slope is uneven, with minor ripples in the stone covering the slope. About 25 feet to the left of the outlet works, the downstream toe is about 6 feet further downstream than at adjacent sections. This appeared to be an as-constructed condition. Tailwater at the dam is caused by Mountain Lake; the upstream end of Mountain Lake is at the toe of the dam (Photograph H). No seepage was observed at the dam.

D. Top of Dam and Downstream Slope

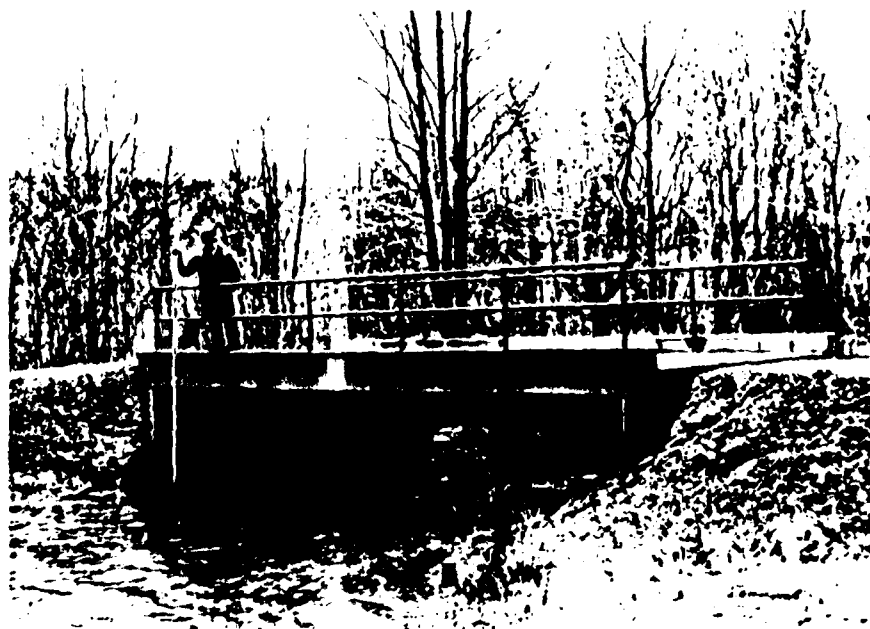
c. Appurtenant Structures. The spillway and spillway bridge are, structurally, in good condition (Photographs F and G). No wingwalls are provided on the structure and the adjacent fill encroaches on the approach channel for 2.5 feet on each side. Two steel I-beams are lying adjacent to the crest. Just downstream of the crest, the spillway walls, which were constructed in 1978, join the remains of the old spillway. The new left wall ends and a short riprap section deflects about 3 feet inward to meet the old spillway wall. The new right wall ends at a short length of earthen slope. The remains of the old spillway extend downstream of the earthen slope. The remains of the old spillway are in very poor condition. Some of the remains are tilting; other parts have wide structural cracks. The channel extends downstream from the spillway in an unprotected earthen channel parallel to the toe of the embankment. There is a minor amount of brush and debris in the channel, which otherwise is in good condition.

F. Spillway Approach

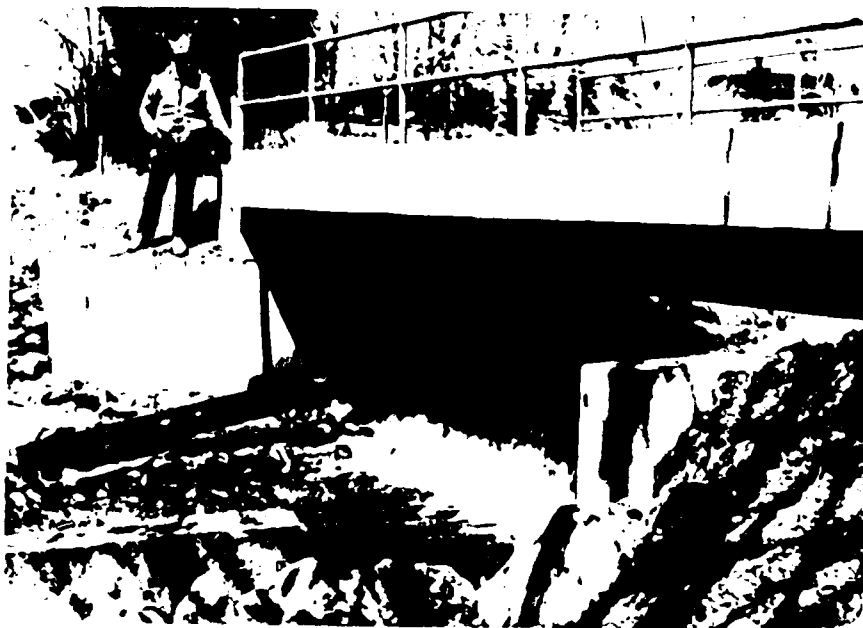
1. Spillway

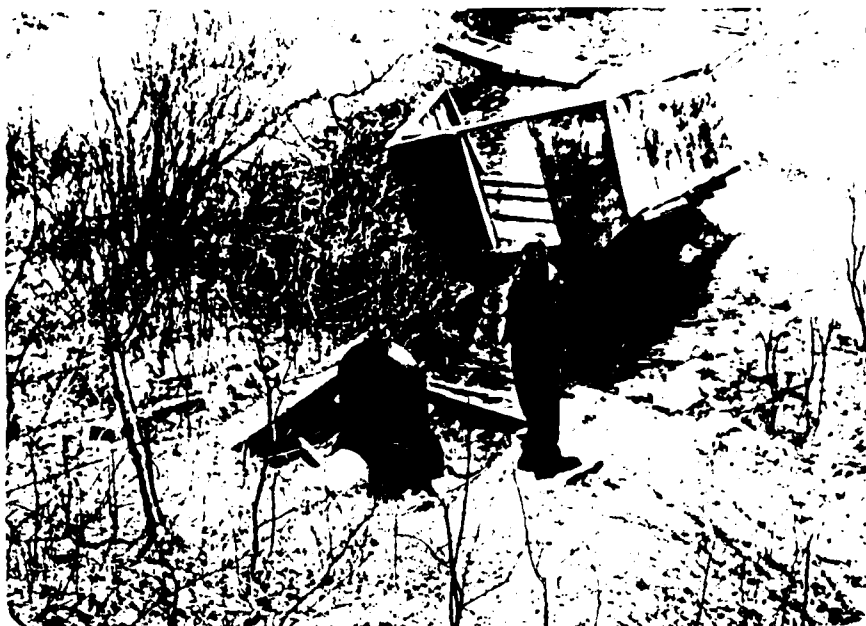
The outlet works is in poor condition. The timber frame gate house is capsized downstream of the gate valve (Photograph I). The gate valve itself has a 1.5-foot long crack through the gate housing. The nuts securing the gate housing are so rusted that only a small portion remains. The Owner's agent offered to operate the valve until he discovered that there was no operating mechanism. He did not recall the valve ever being operated.

(3) Appurtenant Structures. There is no evidence to suggest that the outlet works is operational. There are no upstream closure facilities for the outlet works. The severely-rusted, securing nuts and the cracked gate housing could cause the valve to jam, if it were to be operated. If the outlet works is not operational, there would be no means to draw down the lake in case of an emergency. It is surmised that the timber frame gate house overturned during a strong wind; no means of securing it to the concrete foundation was observed. Even in place, it probably provided only marginal protection against the elements.

I. Outlet Works

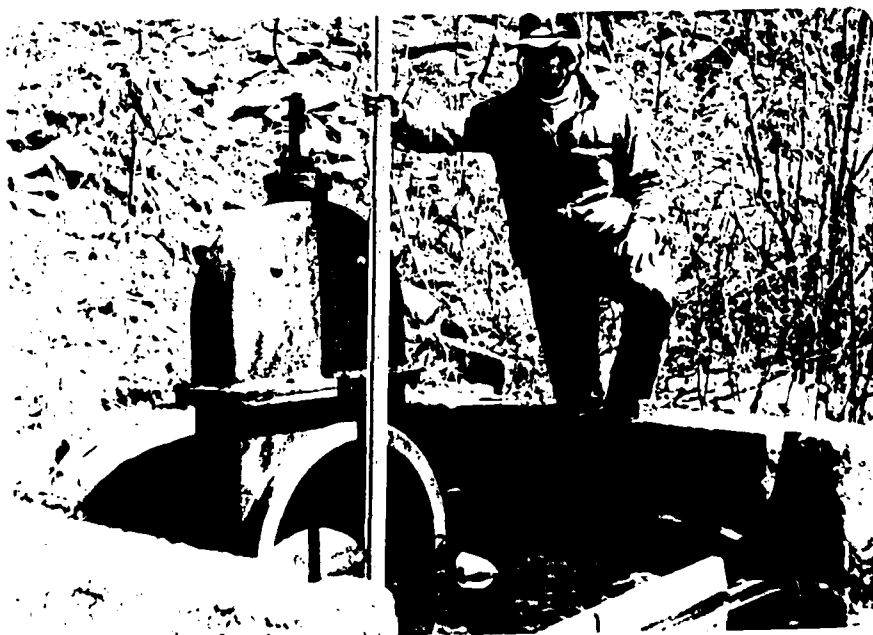
VISUAL EXAMINATION OF	OBSERVATIONS	REMARKS OR RECOMMENDATIONS
CRACKING AND SPALLING OF CONCRETE SURFACES IN OUTLET CONDUIT	CAST-IRON-PIPE (CIP)	GATE VALVE HOUSING CRACKED, CRACK IS 1.5' LONG
INTAKE STRUCTURE	Submerged - NOT VISIBLE	
OUTLET STRUCTURE	CONCRETE FOUNDATION	WOOD-FRAME SUPERSTRUCTURE CAPSIZED ABOUT 20' DOWNSTREAM.
OUTLET CHANNEL	MOUNTAIN LAKE POOL.	
EMERGENCY GATE	NO OPERATING MECHANISM. BOLTS ON VALVE HOUSING ALMOST RUSTED OFF.

II. Outlet Works Valve
